ELECTRICITY INDUSTRY PARTICIPATION CODE  
DISTRIBUTED UNMETERED LOAD AUDIT REPORT

BULLER DISTRICT COUNCIL  
RAMM DATABASE  
AND MERIDIAN ENERGY

Prepared by: Rebecca Elliot

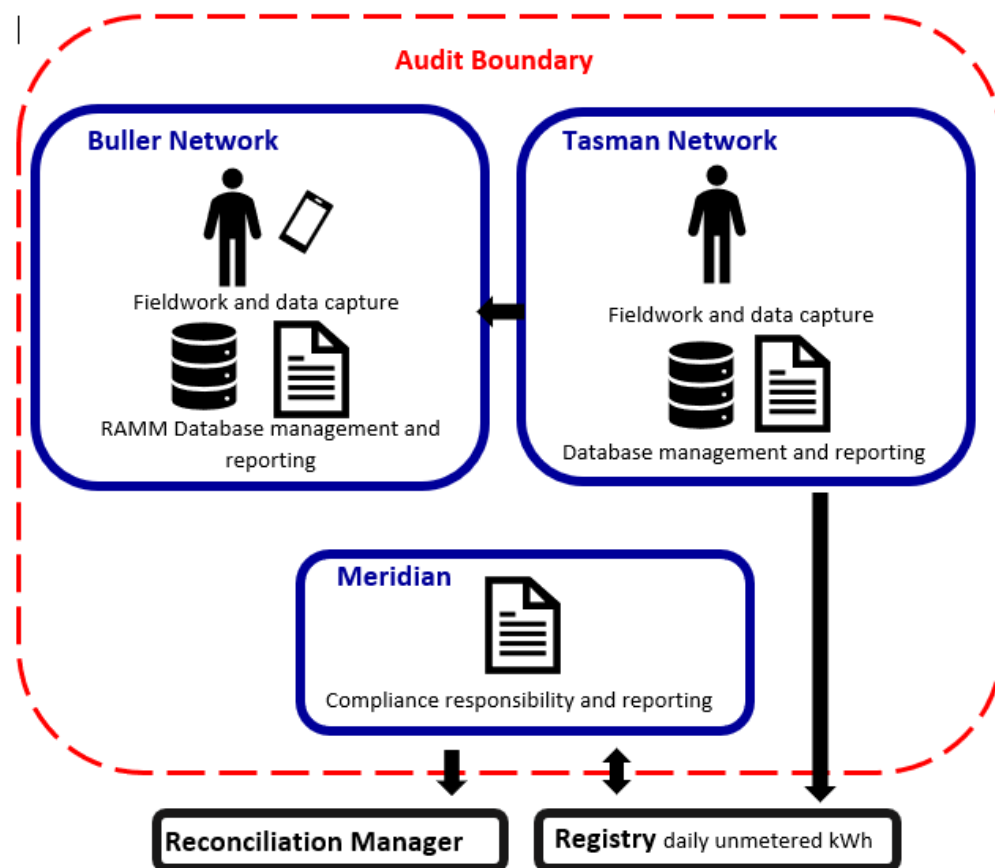
The scope of the audit encompasses the collection, security, and accuracy of the data, including the preparation of submission information based on the database reporting. The diagram below shows the current audit boundary for clarity:

The ElectroNet database has been assessed in its own audit report which will be submitted separately. This report assesses the compliance for the unmetered load recorded in the RAMM database for the DUML load on the Buller and Network Tasman networks. This includes both council and a small number of NZTA lights. Meridian's submission is based on the unmetered daily kWh recorded on the registry for both ICPs.
