ELECTRICITY INDUSTRY PARTICIPATION CODE  
DISTRIBUTED UNMETERED LOAD AUDIT REPORT

PORIRUA CITY COUNCIL  
AND GENESIS ENERGY LIMITED

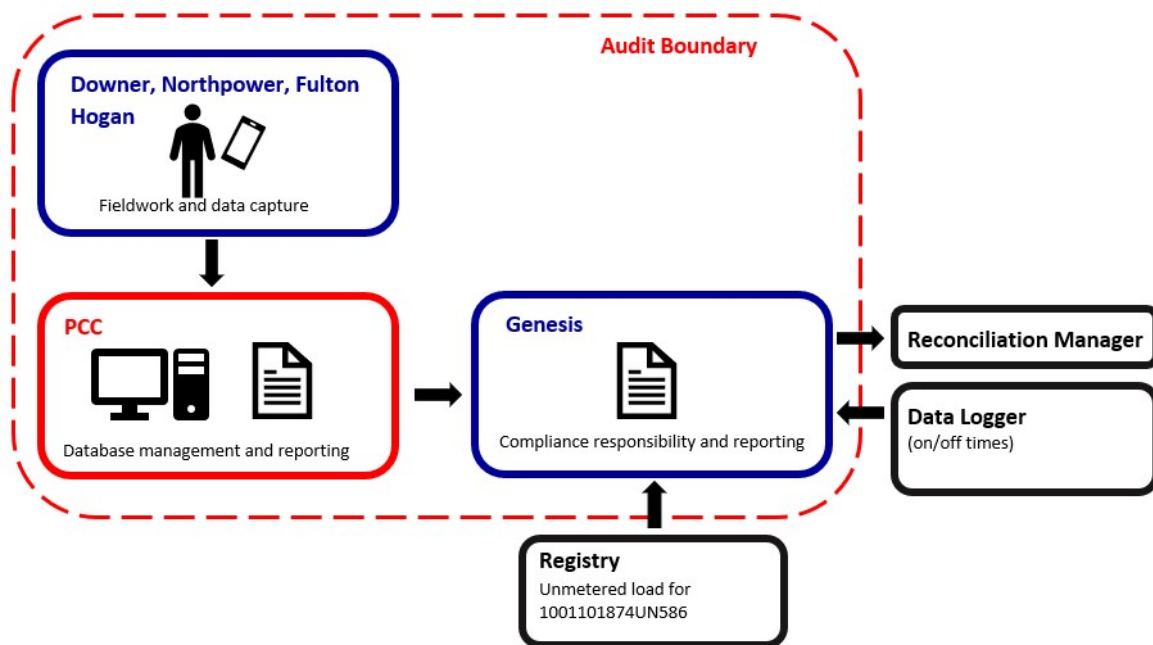
The diagram below shows the audit boundary for clarity.

PCC provides monthly reports from RAMM to Genesis, and these reports are used to calculate submission information. ICP 1001101874UN586 (Traffic Lights - Transit Mana Esplanade, State Highway 1, Plimmerton) is not recorded in the database. These lights are settled with UNM profile based on the unmetered load details currently recorded on the registry.
