# ELECTRICITY INDUSTRY PARTICIPATION CODE DISTRIBUTED UNMETERED LOAD AUDIT REPORT

# WAIROA DISTRICT COUNCIL AND GENESIS ENERGY

Prepared by: Rebecca Elliot

Date audit commenced: 1 October 2018

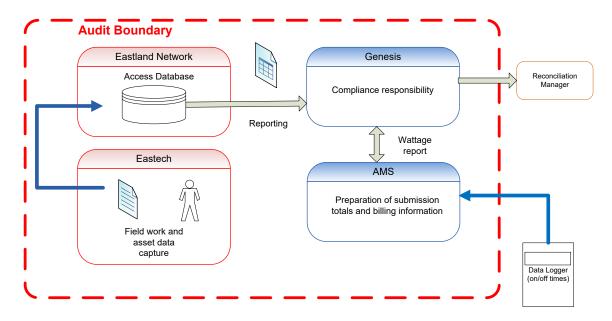
Eastland data is contained in an Access database and Eastland provides reporting to Genesis on a monthly basis, detailing the total kW per ICP and the on/off times are derived by a data logger interrogated by AMS. Lamp ballast information is not stored in the database, instead is calculated at the time of billing.

The diagram below shows the audit boundary for clarity.
