ELECTRICITY INDUSTRY PARTICIPATION CODE
DISTRIBUTED UNMETERED LOAD AUDIT REPORT

TARARUA DISTRICT COUNCIL
AND GENESIS ENERGY LIMITED

Prepared by: Tara Gannon

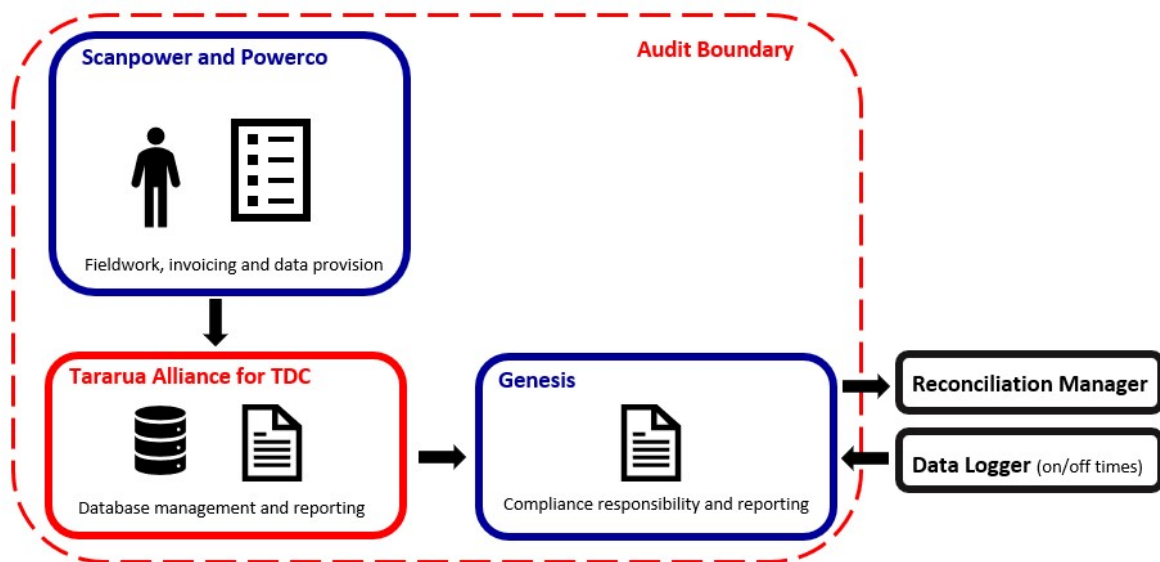
The scope of the audit encompasses the collection, security, and accuracy of the data, including the preparation of submission information based on the monthly reporting. The diagram below shows the flow of information and the audit boundary for clarity.
