ELECTRICITY INDUSTRY PARTICIPATION CODE
DISTRIBUTED UNMETERED LOAD AUDIT REPORT

BULLER DISTRICT COUNCIL
RAMM DATABASE
AND MERIDIAN ENERGY

Prepared by: Rebecca Elliot

Date audit commenced: 16 September 2019

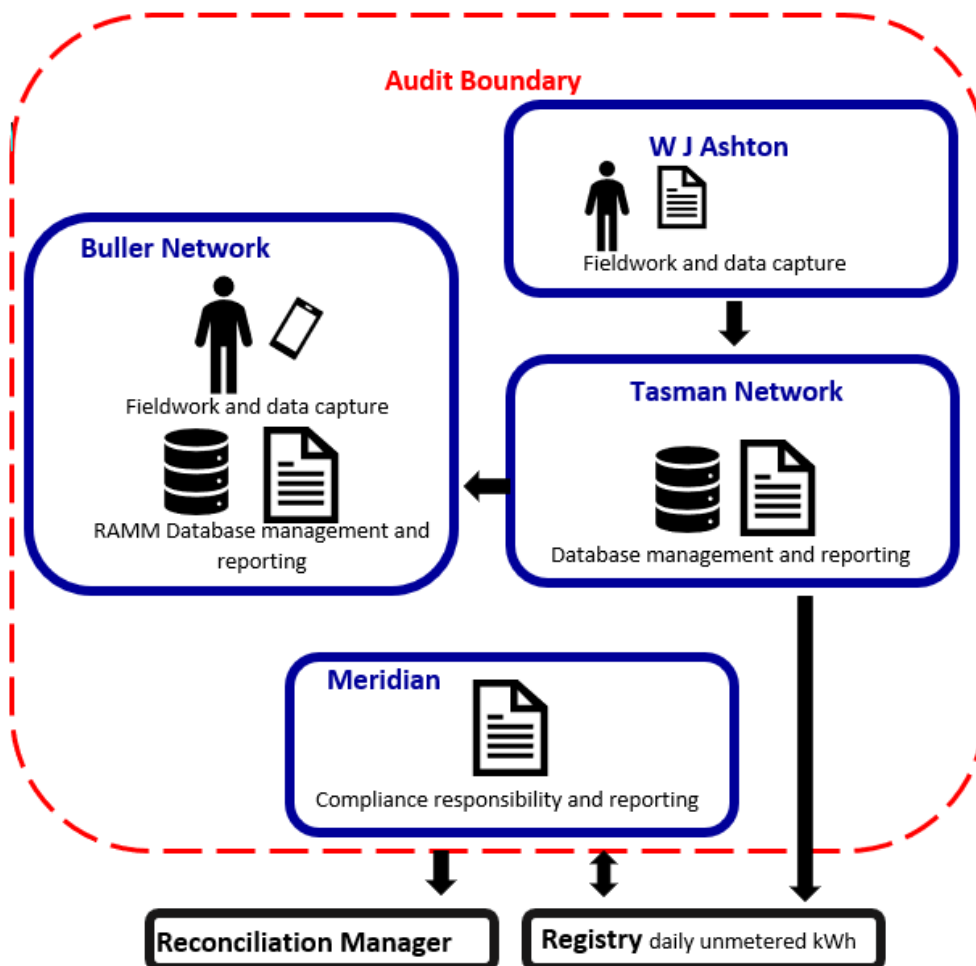
The scope of the audit encompasses the collection, security, and accuracy of the data, including the preparation of submission information based on the database reporting. The diagram below shows the audit boundary for clarity:
