# ELECTRICITY INDUSTRY PARTICIPATION CODE DISTRIBUTED UNMETERED LOAD AUDIT REPORT

# KAWAKAWA COMMUNITY LIGHTING AND TRUSTPOWER

Prepared by: Rebecca Elliot

Date audit commenced: 19 November 2019

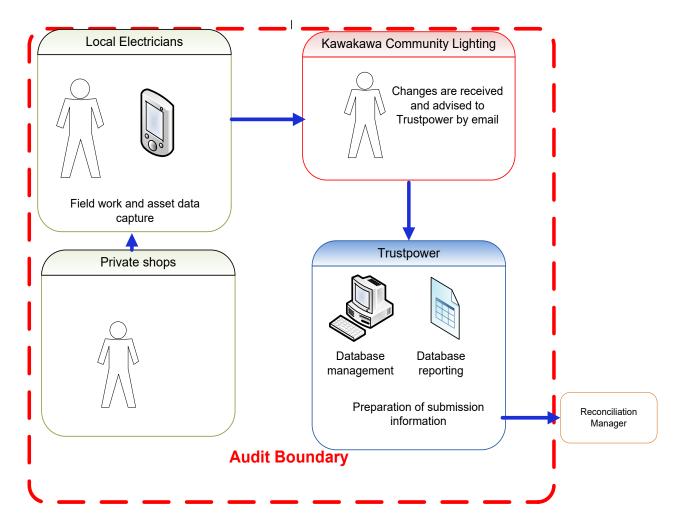
The scope of the audit encompasses the collection, security and accuracy of the data, including the preparation of submission information based on the monthly reporting. The diagram below shows the flow of information and the audit boundary for clarity.

Kawakawa Community Lighting is located on the Top Energy network. The Kawakawa Business Association arranges any required maintenance. Changes are reported to Trustpower to be recorded in the database. The database is used by Trustpower to calculate submission information.
