ELECTRICITY INDUSTRY PARTICIPATION CODE DISTRIBUTED UNMETERED LOAD AUDIT REPORT

TASMAN DISTRICT COUNCIL AND TASMAN NZTA AND CONTACT ENERGY LIMITED

Prepared by: Rebecca Elliot

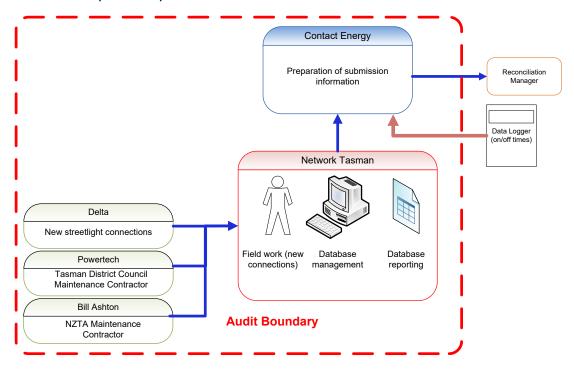
The scope of the audit encompasses the collection, security and accuracy of the data, including the preparation of submission information based on the database reporting. The diagram below shows the audit boundary for clarity.
