**ELECTRICITY INDUSTRY PARTICIPATION CODE
DISTRIBUTED UNMETERED LOAD AUDIT REPORT**

**TAURANGA NZTA AND TRUSTPOWER
LIMITED**

Prepared by: Steve Woods

Date audit commenced: 19 November 2019

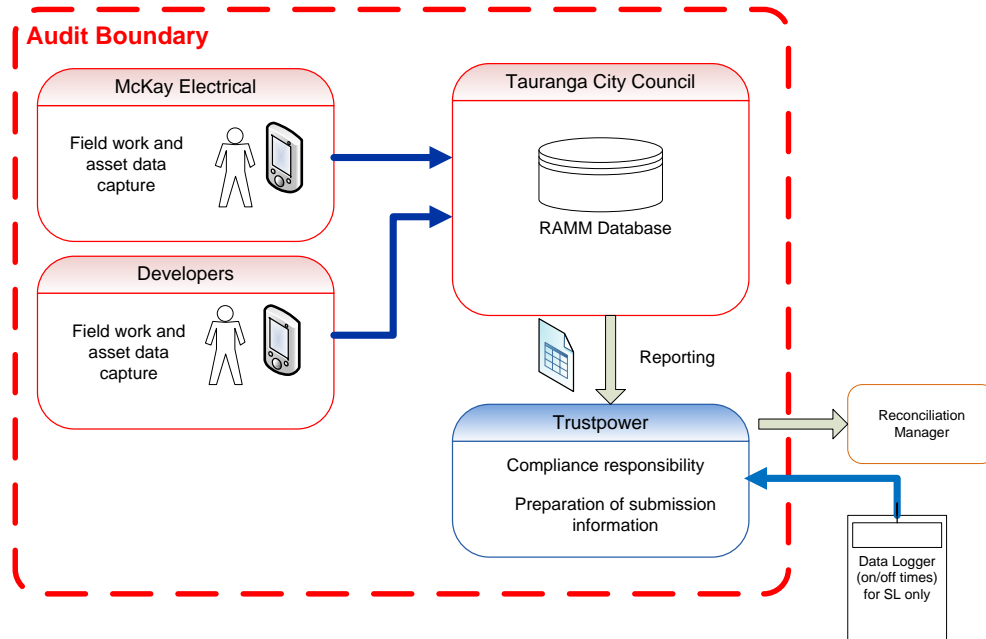
The database used for submission is managed by TCC. The field work and asset data capture is conducted by McKay Electrical and they update the TCC RAMM database using “Pocket RAMM”.

The diagram below shows the current flow of information and the audit boundary for clarity.
