ELECTRICITY INDUSTRY PARTICIPATION CODE  
DISTRIBUTED UNMETERED LOAD AUDIT REPORT

HAMILTON CITY COUNCIL AND  
MERIDIAN ENERGY

Prepared by: Steve Woods

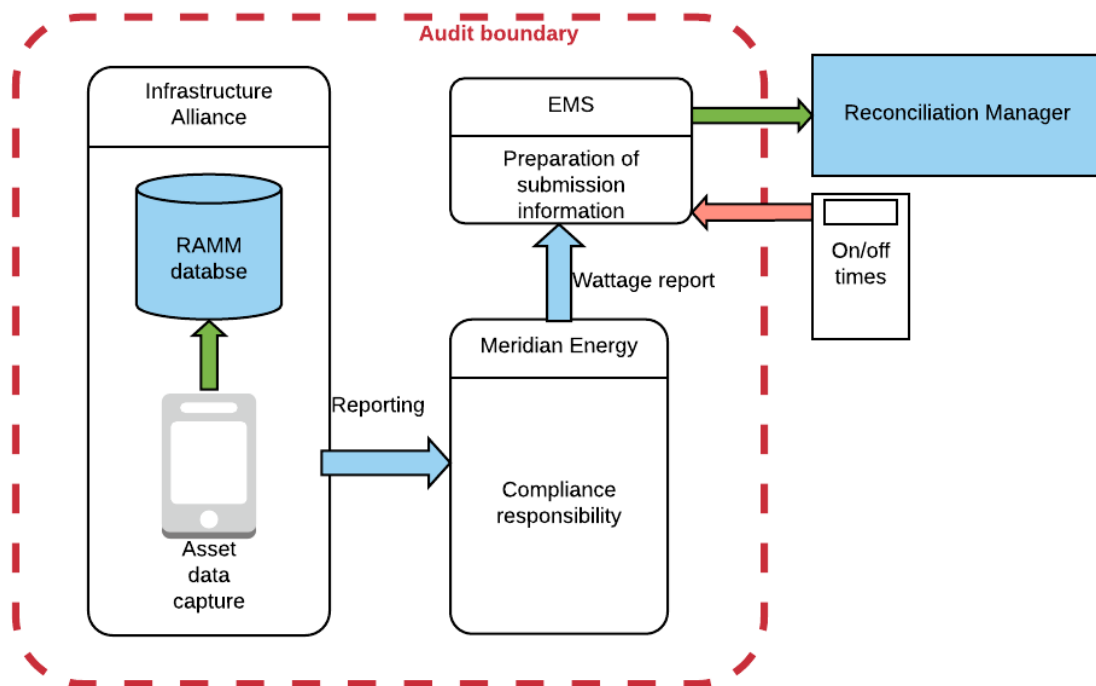
The scope of the audit encompasses the collection, security and accuracy of the data, including the preparation of submission information based on the database reporting. The diagram below shows the audit boundary for the current arrangements for clarity.

The database is remotely hosted by RAMM Software Ltd and is managed by Infrastructure Alliance, on behalf of HCC, HCC being Meridian's customer. Infrastructure Alliance is a joint venture between HCC and Downer which provides infrastructure management across all of HCC assets. They provide reporting to Meridian on a monthly basis.
