ELECTRICITY INDUSTRY PARTICIPATION CODE DISTRIBUTED UNMETERED LOAD AUDIT REPORT

SOUTHLAND DISTRICT COUNCIL AND GENESIS ENERGY

Prepared by: Rebecca Elliot

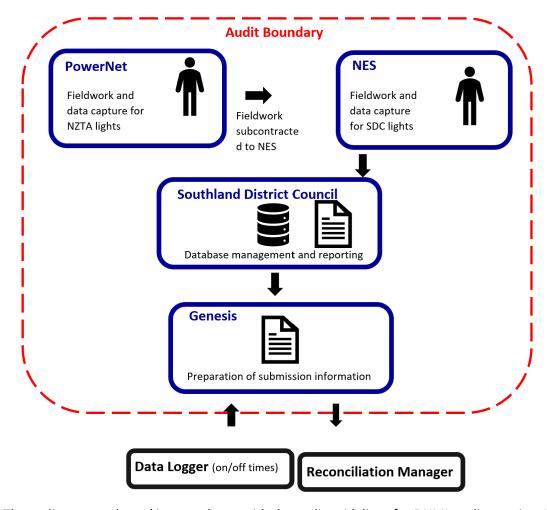
The scope of the audit encompasses the collection, security and accuracy of the data, including the preparation of submission information based on the database reporting. SDC have engaged NES to maintain their lights. PowerNet remain the contractor to maintain the NZTA lights. They have engaged NES to undertake the field work so effectively it is the one contractor undertaking the field work. The diagram below shows the audit boundary for clarity.
