ELECTRICITY INDUSTRY PARTICIPATION CODE
DISTRIBUTED UNMETERED LOAD AUDIT REPORT

SOUTH WAIRARAPA DISTRICT COUNCIL
AND MERCURY ENERGY LIMITED

Prepared by: Tara Gannon

Date audit commenced: 17 March 2020

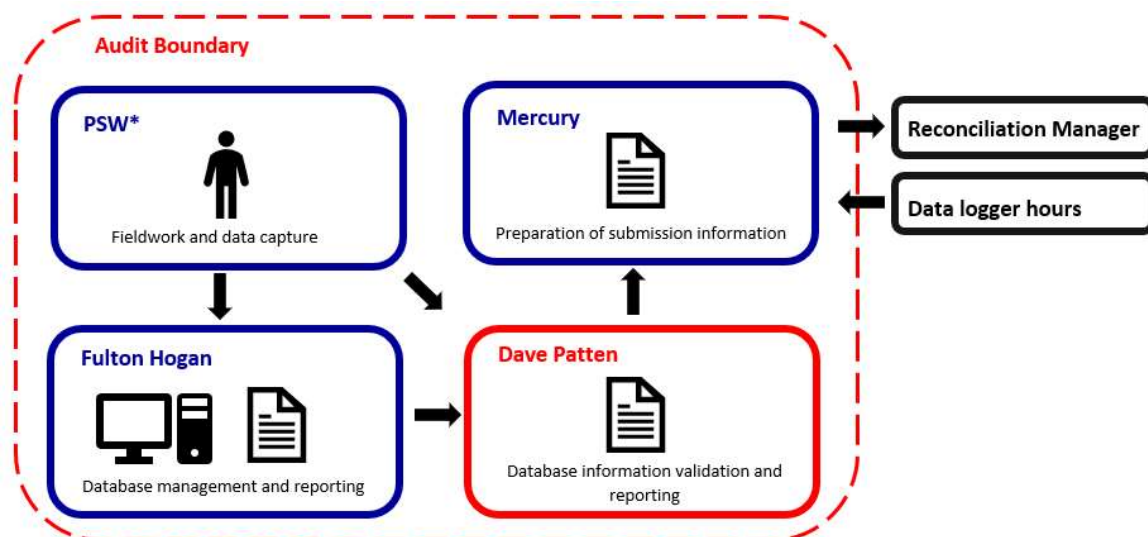
The scope of the audit encompasses the collection, security and accuracy of the data, including the preparation of submission information based on the database reporting. The diagram below shows the audit boundaries for clarity.

*with assistance from Fulton Hogan as required
