**ELECTRICITY INDUSTRY PARTICIPATION CODE
DISTRIBUTED UNMETERED LOAD AUDIT REPORT**

**TAUPO DISTRICT COUNCIL
AND MERIDIAN**

Prepared by: Steve Woods

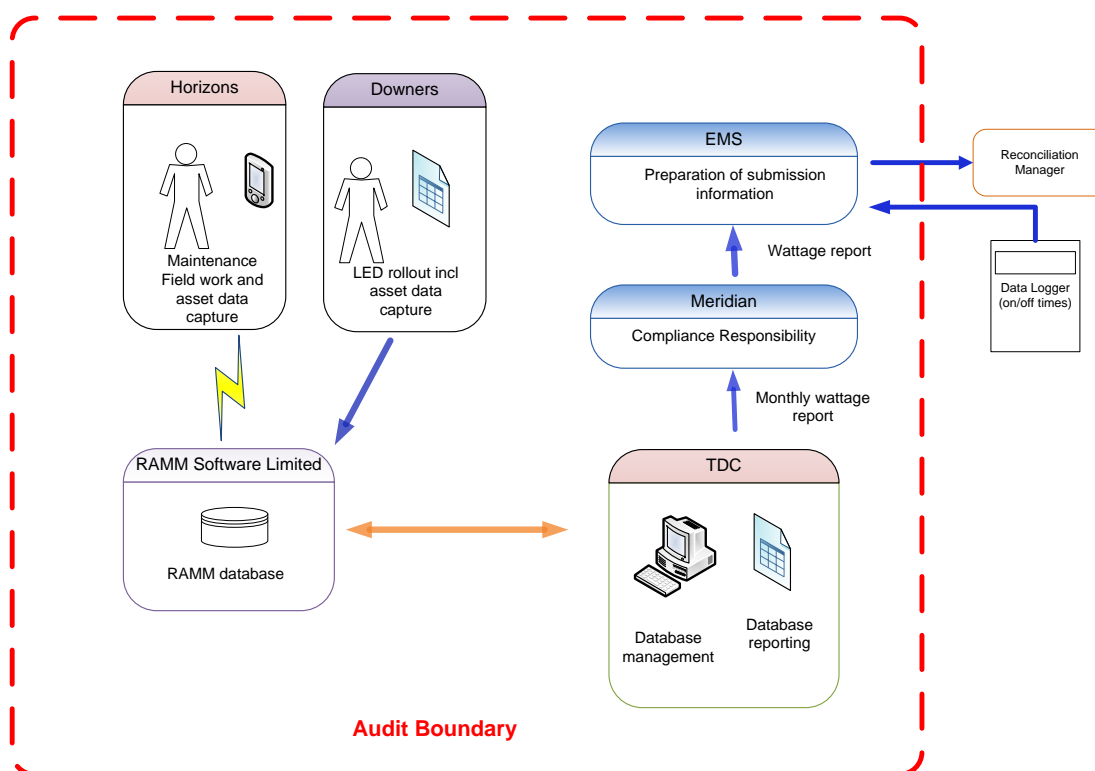
The scope of the audit encompasses the collection, security and accuracy of the data, including the preparation of submission information based on the database reporting. The diagram below shows the audit boundary for clarity.
