ELECTRICITY INDUSTRY PARTICIPATION CODE  
DISTRIBUTED UNMETERED LOAD AUDIT REPORT

HUTT CITY COUNCIL AND CONTACT  
ENERGY LIMITED

Prepared by: Rebecca Elliot

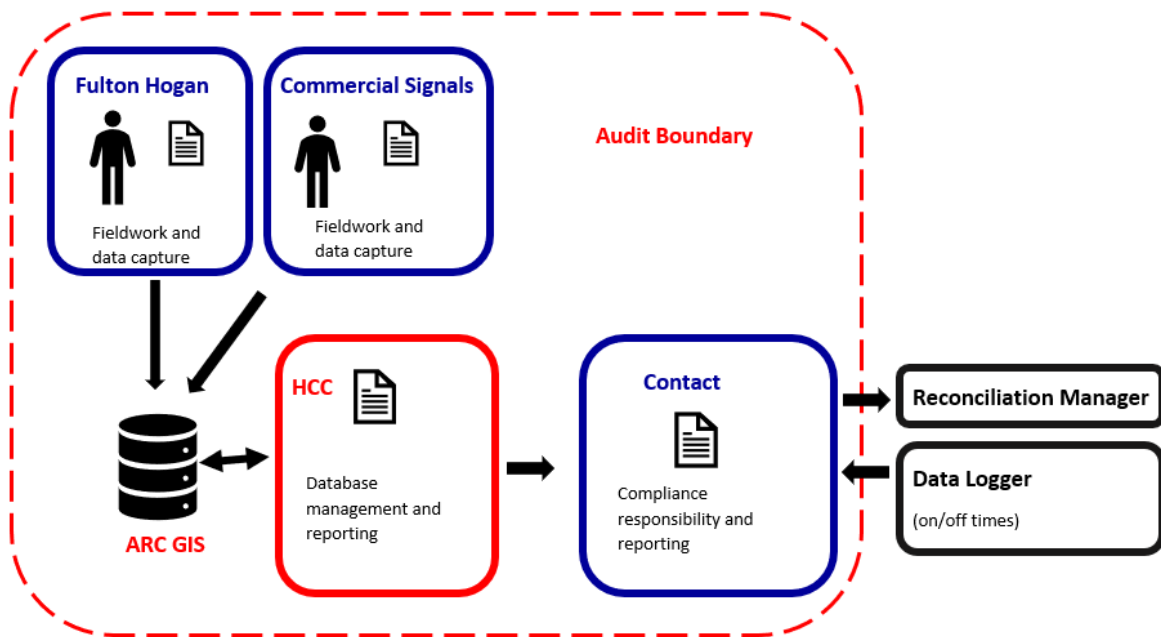
The scope of the audit encompasses the collection, security and accuracy of the data, including the preparation of submission information based on the database reporting. The diagram below shows the audit boundary for clarity.

Streetlight information is recorded in a GIS database managed by HCC. New connection, fault and maintenance work is largely completed by Fulton Hogan, who update the ARC GIS database based on paperwork returned from the field to the Fulton Hogan office. HCC also use Commercial Signals for the more complicated work. Updates to the database are provided in the same way for both contractors. HCC provide a monthly report to Contact from ARC GIS.
