**ELECTRICITY INDUSTRY PARTICIPATION CODE
DISTRIBUTED UNMETERED LOAD AUDIT REPORT**

NZTA NAPIER AND MERIDIAN ENERGY

Prepared by: Rebecca Elliot

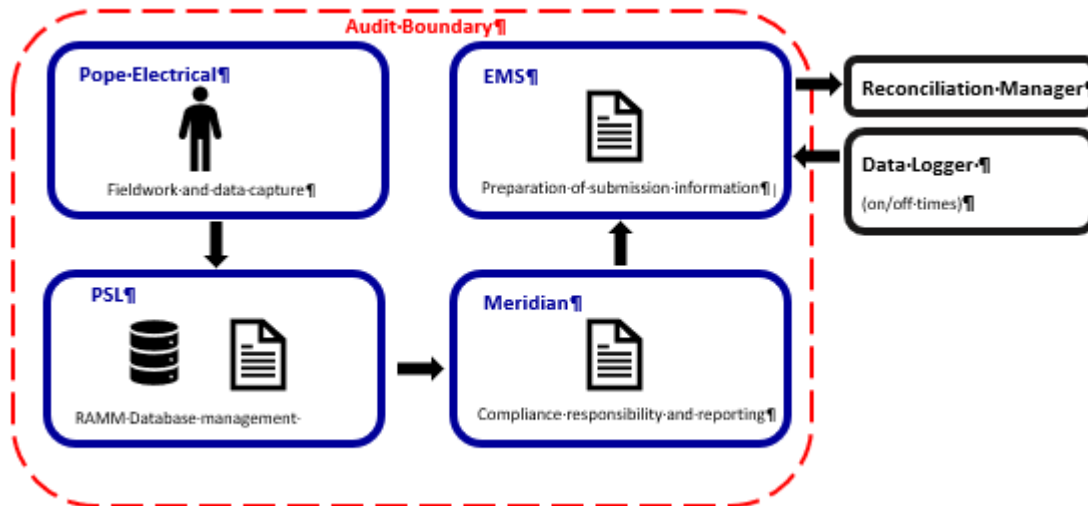
The database is remotely hosted by RAMM Software Ltd and is managed by Power Solutions Limited (PSL), on behalf of Napier NZTA, who is Meridian’s customer. Reporting is provided by PSL to Meridian on a monthly basis. The fieldwork and asset data capture are conducted by Pope Electrical. The scope of the audit encompasses the collection, security and accuracy of the data, including the preparation of submission information based on the database reporting. The diagram below shows the audit boundary for clarity.
