## ELECTRICITY INDUSTRY PARTICIPATION CODE DISTRIBUTED UNMETERED LOAD AUDIT REPORT

# RNZAF WOODBOURNE DUML AND MERIDIAN

Prepared by: Rebecca Elliot

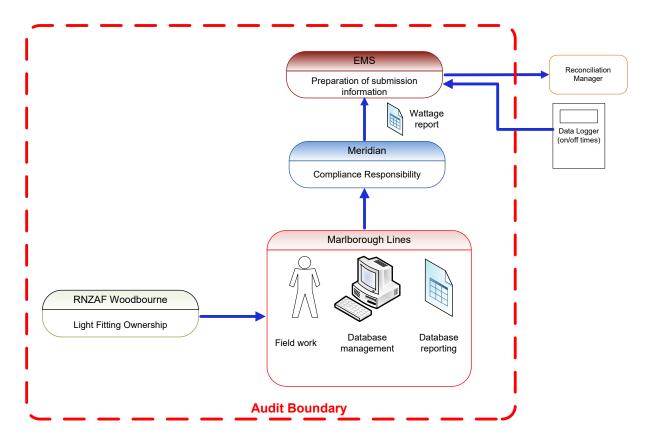
Marlborough Lines manage the installation, maintenance and database management of the DUML for RNZAF Woodbourne. Reporting is provided to Meridian on a monthly basis. The scope of the audit encompasses the collection, security and accuracy of the data, including the preparation of submission information based on the database reporting.

The diagram below shows the audit boundary for clarity.
