ELECTRICITY INDUSTRY PARTICIPATION CODE  
DISTRIBUTED UNMETERED LOAD AUDIT REPORT

DUNEDIN CITY COUNCIL  
AND CONTACT ENERGY LIMITED

Prepared by: Rebecca Elliot

Date audit commenced: 19 October 2020

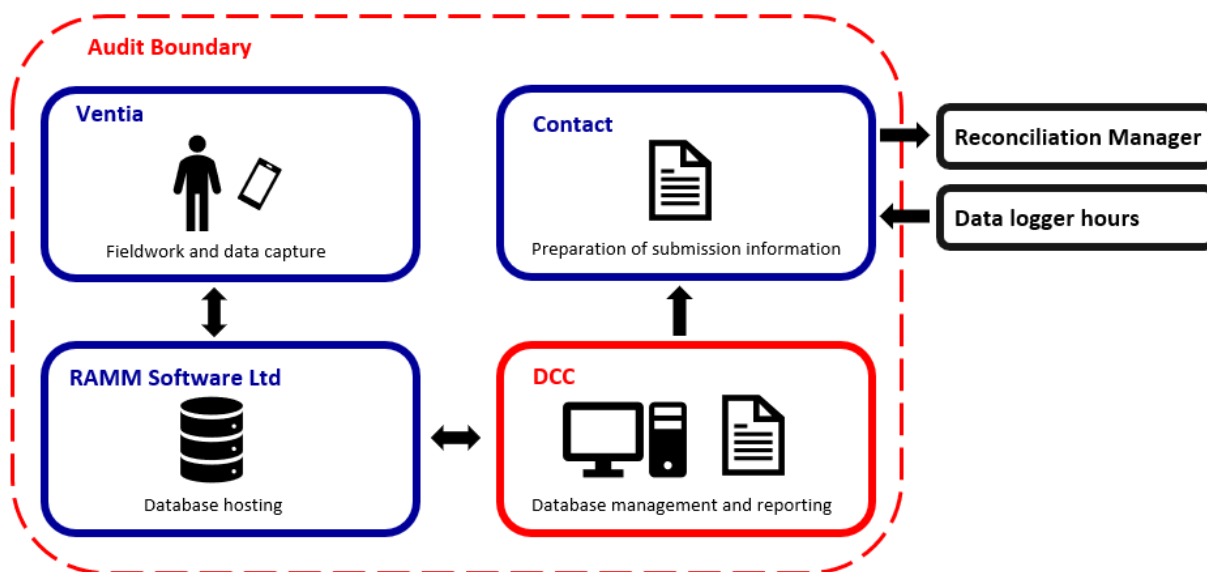
The scope of the audit encompasses the collection, security, and accuracy of the data, including the preparation of submission information based on the database reporting. The diagram below shows the audit boundaries for clarity.

A monthly report from the database is provided to Contact, and used to calculate submissions. Contact submits the DUML load as HHR using the HHR profile. On hours are derived using data logger information.
