**ELECTRICITY INDUSTRY PARTICIPATION CODE
DISTRIBUTED UNMETERED LOAD AUDIT REPORT**

**WELLINGTON CITY COUNCIL AND GENESIS
ENERGY**

Prepared by: Steve Woods

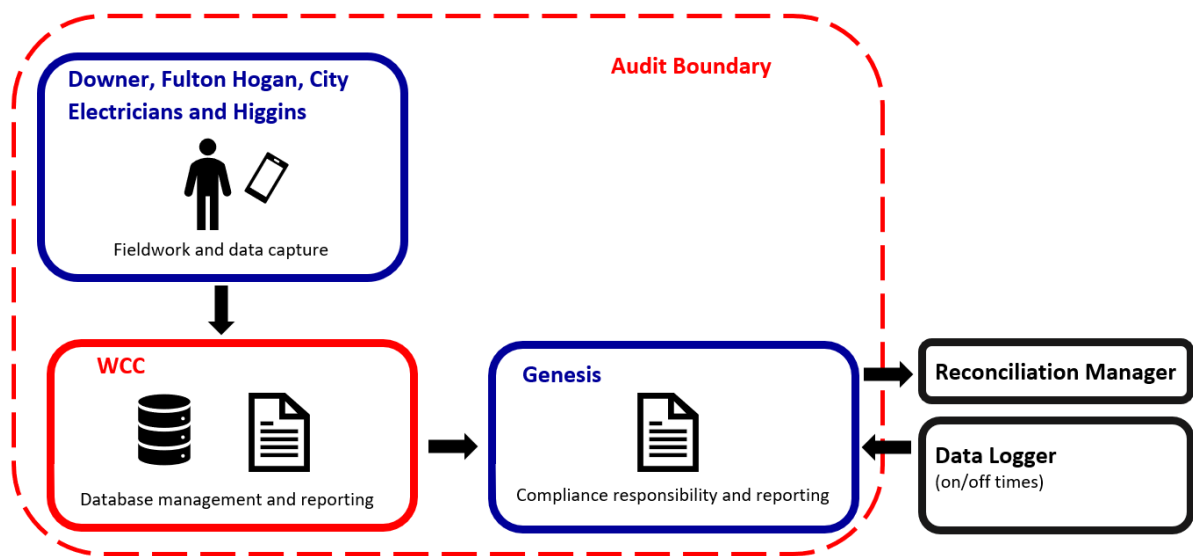
The scope of the audit encompasses the collection, security, and accuracy of the data, including the preparation of submission information based on the database reporting. The diagram below shows the audit boundary for clarity.
