**ELECTRICITY INDUSTRY PARTICIPATION CODE
DISTRIBUTED UNMETERED LOAD AUDIT REPORT**

**KAIKOURA DISTRICT COUNCIL
AND MERIDIAN ENERGY**

Prepared by: Steve Woods

Date audit commenced: 14 April 2021

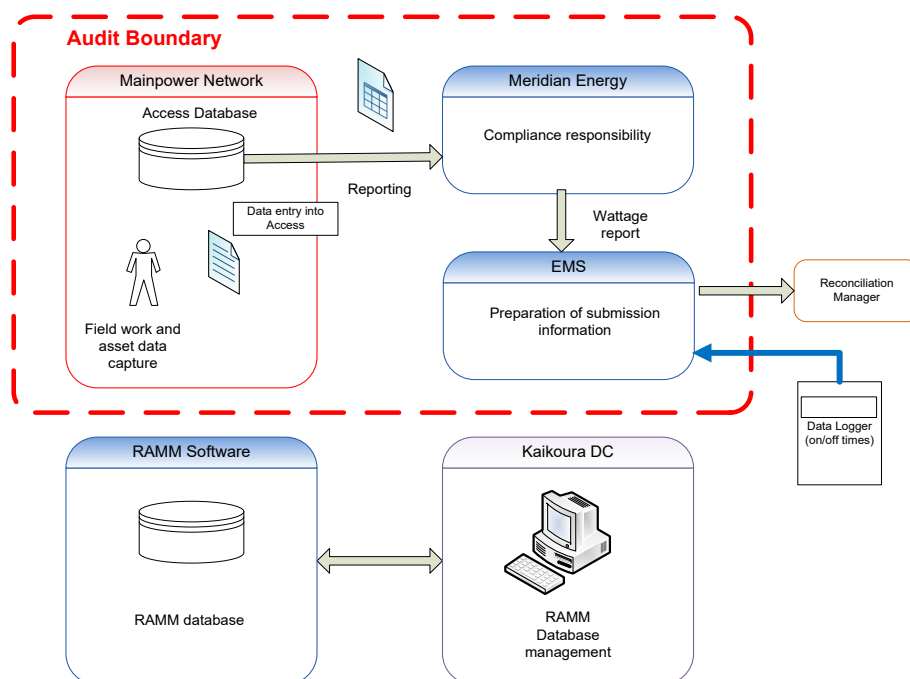
The scope of the audit encompasses the collection, security and accuracy of the data, including the preparation of submission information based on the monthly reporting. The diagram below shows the flow of information and the audit boundary for clarity.

Kaikoura DC is located on the Mainpower network. Mainpower is engaged as the streetlighting maintenance contractor and they also maintain a database, which is used by Meridian Energy to calculate submission information. Mainpower provides reporting to Meridian Energy on a monthly basis.
