**ELECTRICITY INDUSTRY PARTICIPATION CODE
DISTRIBUTED UNMETERED LOAD AUDIT REPORT**

**TAURANGA CITY COUNCIL AND
TRUSTPOWER LIMITED**

Prepared by: Rebecca Elliot

Date audit report completed: 27 November 2020

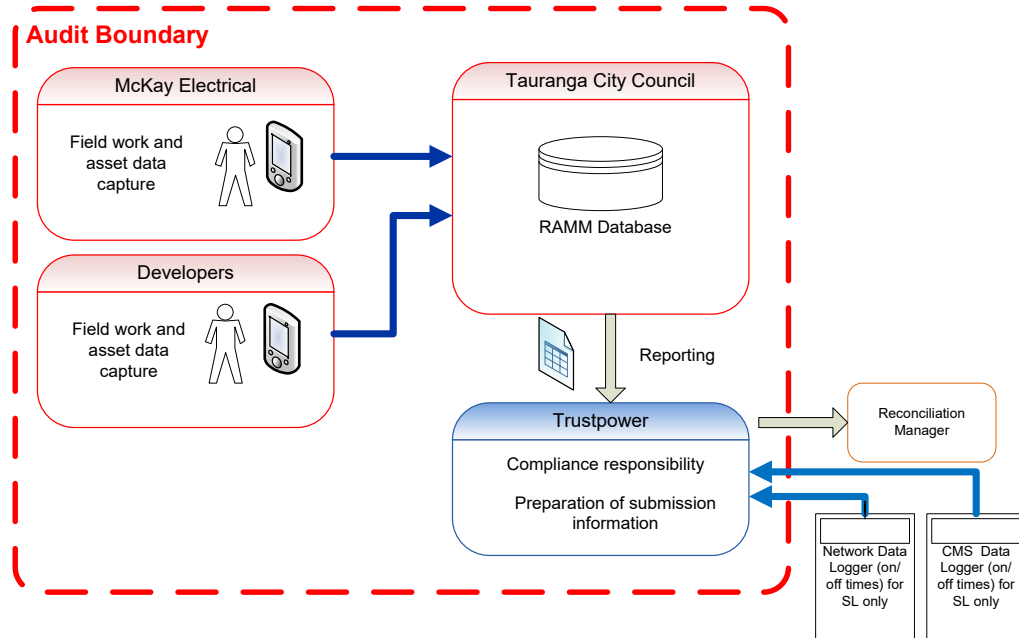
The diagram below shows the current flow of information and the audit boundary for clarity.

The database used for submission is managed by TCC. The field work and asset data capture is conducted by McKay Electrical and they update the TCC RAMM database using “Pocket RAMM”. Reporting is provided to Trustpower on a monthly basis.
