ELECTRICITY INDUSTRY PARTICIPATION CODE
DISTRIBUTOR AUDIT REPORT

ELECTRICITY ASHBURTON LIMITED

Prepared by: Rebecca Elliot

Date audit commenced: 14 June 2021

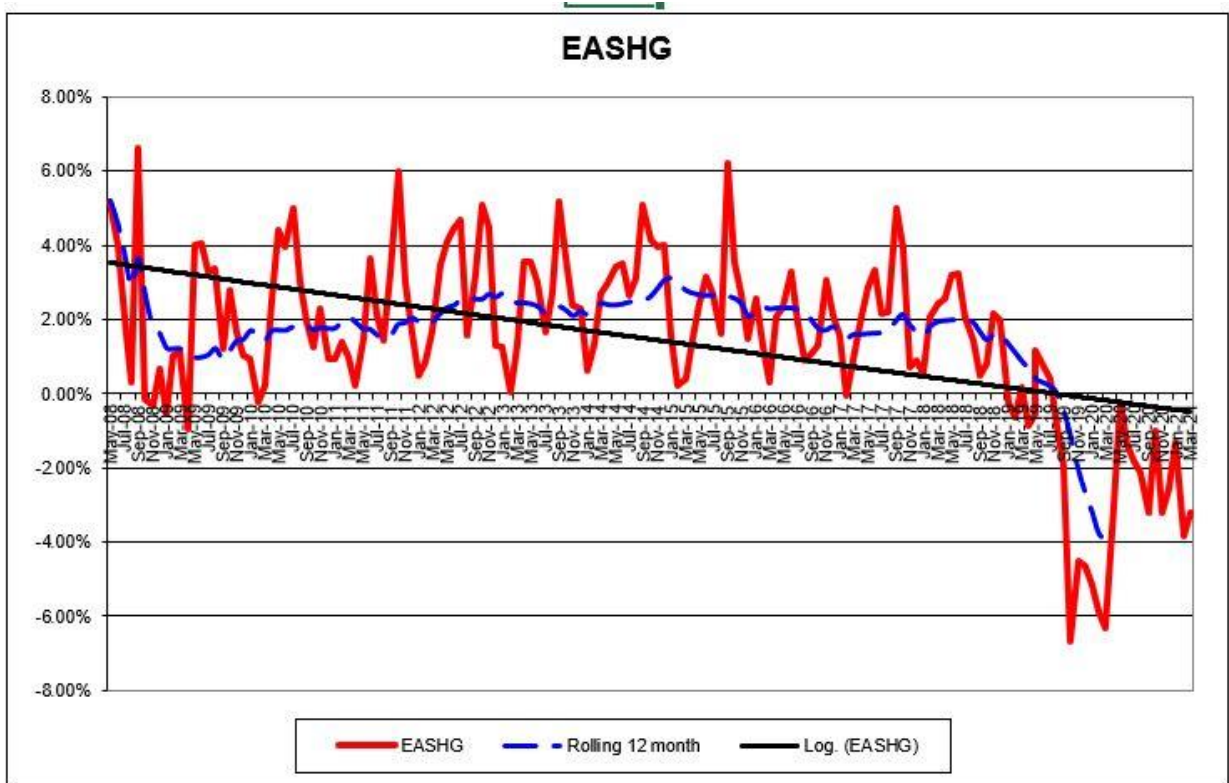
EA Networks losses are tracking within the accepted +/-1% threshold.

A loss factor review was completed in January 2021, and the previous review was completed in January 2020. Following the review updated loss factors were published and recorded on the registry effective from 01/04/21. I confirmed that the updated loss factors recorded on the registry were consistent with the revised loss factor calculations.
