ELECTRICITY INDUSTRY PARTICIPATION CODE
DISTRIBUTED UNMETERED LOAD AUDIT REPORT

SOUTH WAIRARAPA DISTRICT COUNCIL
AND MERCURY NZ LIMITED

Date audit commenced: 22 September 2021

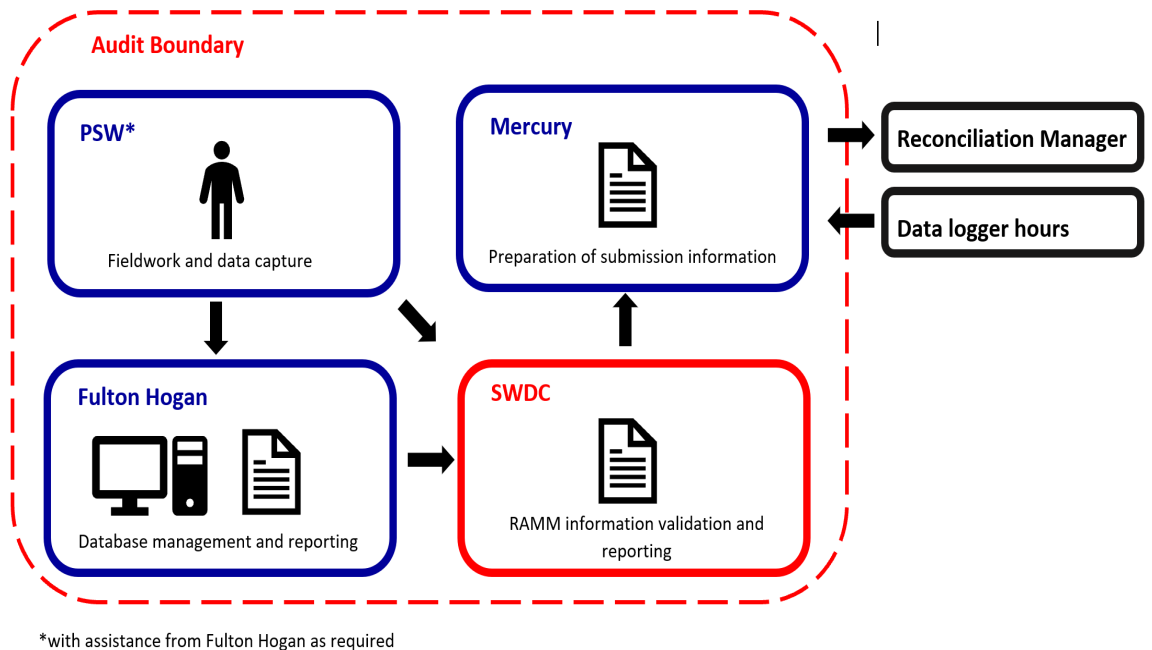
The scope of the audit encompasses the collection, security and accuracy of the data, including the preparation of submission information based on the database reporting. The diagram below shows the audit boundaries for clarity.
