**ELECTRICITY INDUSTRY PARTICIPATION CODE
DISTRIBUTED UNMETERED LOAD AUDIT REPORT**

**NZTA CENTRAL OTAGO AURORA DATABASE
AND TRUSTPOWER**

Prepared by: Rebecca Elliot

Date audit report completed: 17 February 2022

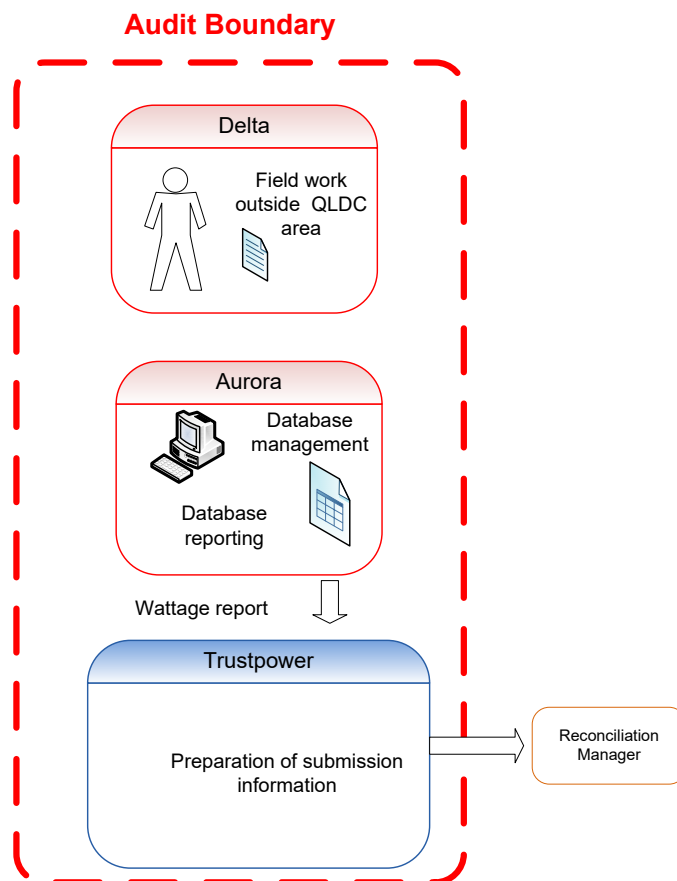
The scope of the audit encompasses the collection, security and accuracy of the data, including the preparation of submission information based on the monthly reporting. The diagram below shows the flow of information and the audit boundary for clarity.

The database is managed by Aurora and the data is held in their GIS system. Delta is the field contractor for Central Otago NZTA outside of the QLDC area, on the Aurora Network. Delta advises the Council of any changes as a result of field work. This was previously provided to Aurora by way of a monthly file on the first working day of the month and updated in GIS. This arrangement is no longer in place and ceased on 1 July 2021; there is currently no mechanism for updating the Aurora data base.
