ELECTRICITY INDUSTRY PARTICIPATION CODE  
DISTRIBUTED UNMETERED LOAD AUDIT REPORT

CENTRAL OTAGO DISTRICT COUNCIL  
RAMM DATABASE  
AND CONTACT ENERGY  
NZBN: 9429038549977

Prepared by: Steve Woods

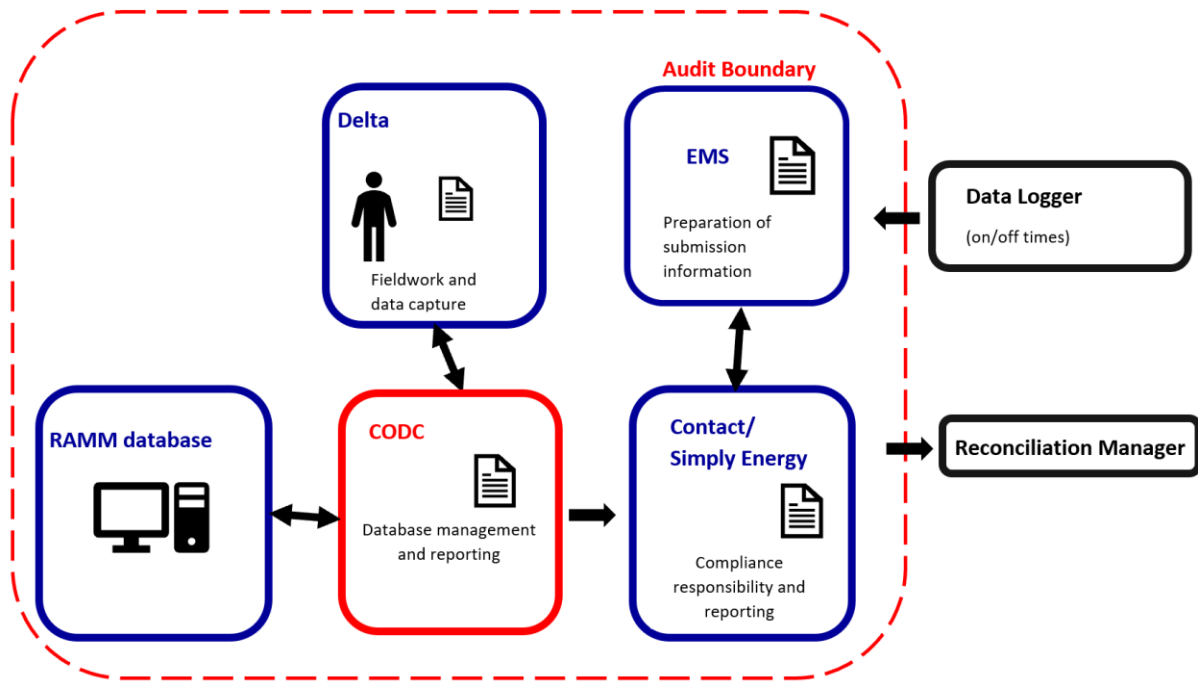
The RAMM database is managed by CODC and is remotely hosted by thinkproject New Zealand Limited. The field work is carried out by Delta. The asset data capture and database population are conducted by CODC. The scope of the audit encompasses the collection, security and accuracy of the data, including the preparation of submission information. The diagram below shows the audit boundary for clarity.
