ELECTRICITY INDUSTRY PARTICIPATION CODE
DISTRIBUTED UNMETERED LOAD AUDIT REPORT

TARARUA DISTRICT COUNCIL
AND GENESIS ENERGY LIMITED
NZBN: 9429037706609

Prepared by: Steve Woods

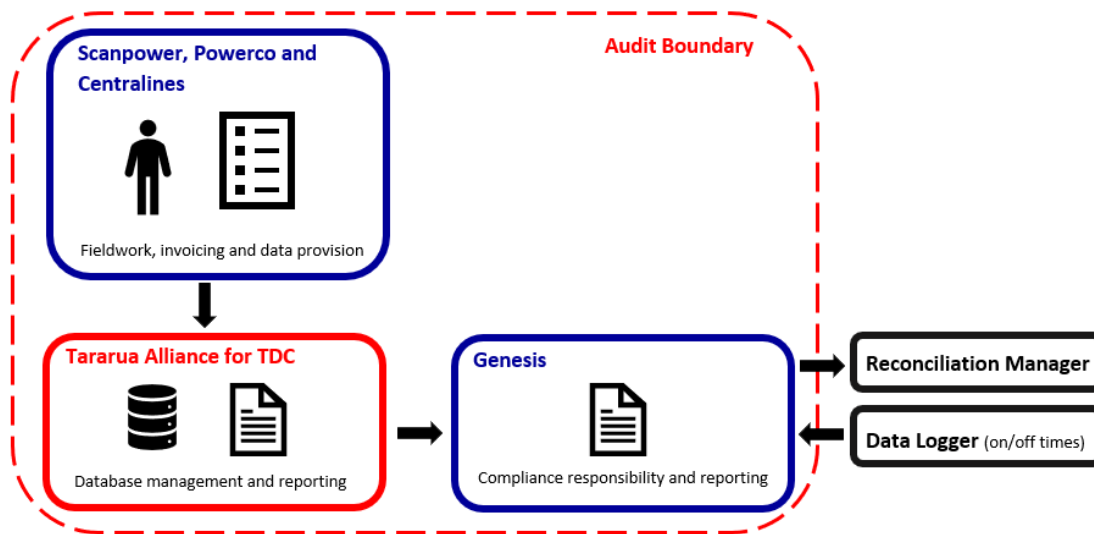
The scope of the audit encompasses the collection, security, and accuracy of the data, including the preparation of submission information based on the monthly reporting. The diagram below shows the flow of information and the audit boundary for clarity.
