**ELECTRICITY INDUSTRY PARTICIPATION CODE
DISTRIBUTED UNMETERED LOAD AUDIT REPORT**

**TAURANGA WAKA KOTAHI AND MANAWA
ENERGY LIMITED**

Prepared by: Steve Woods

Date audit commenced: 15 July 2022

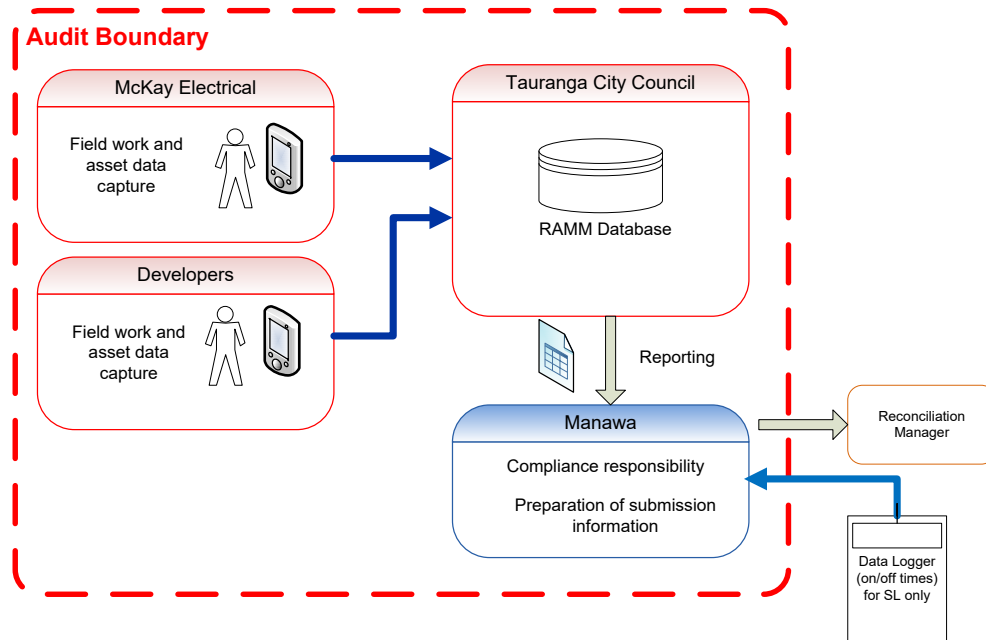
The database used for submission is managed by TCC. The field work and asset data capture is conducted by McKay Electrical and they update the TCC RAMM database using “Pocket RAMM”.

The diagram below shows the current flow of information and the audit boundary for clarity.
