**ELECTRICITY INDUSTRY PARTICIPATION CODE  
RECONCILIATION PARTICIPANT AUDIT REPORT**

**MERCURY NZ LIMITED**  
**NZBN: 9429037705305**

Date audit commenced: 1 December 2021

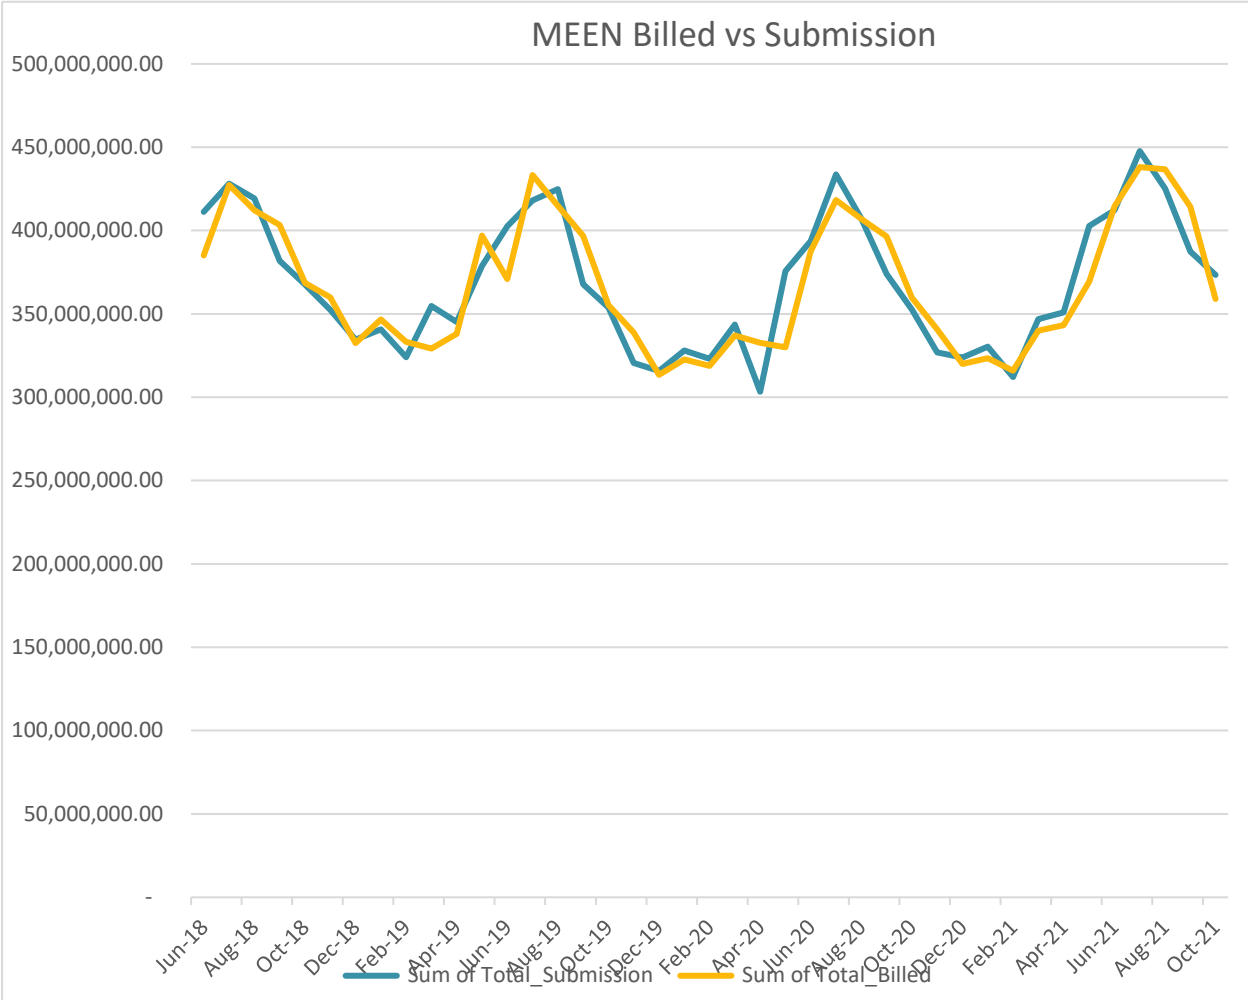
**Comparison between Submitted Volumes and Electricity Supplied**

The chart below shows a comparison between submissions and electricity supplied information. At an aggregate level, billed data is 0.3% higher than submitted data for the year ended October 2021 and 0.1% higher than submission for the two years ended October 2021.
